APOLLO 17

30-DAY FAILURE AND ANOMALY LISTING REPORT

APOLLO 17
30-DAY FAILURE AND ANOMALY LISTING REPORT

PREPARED BY
Mission Evaluation Team

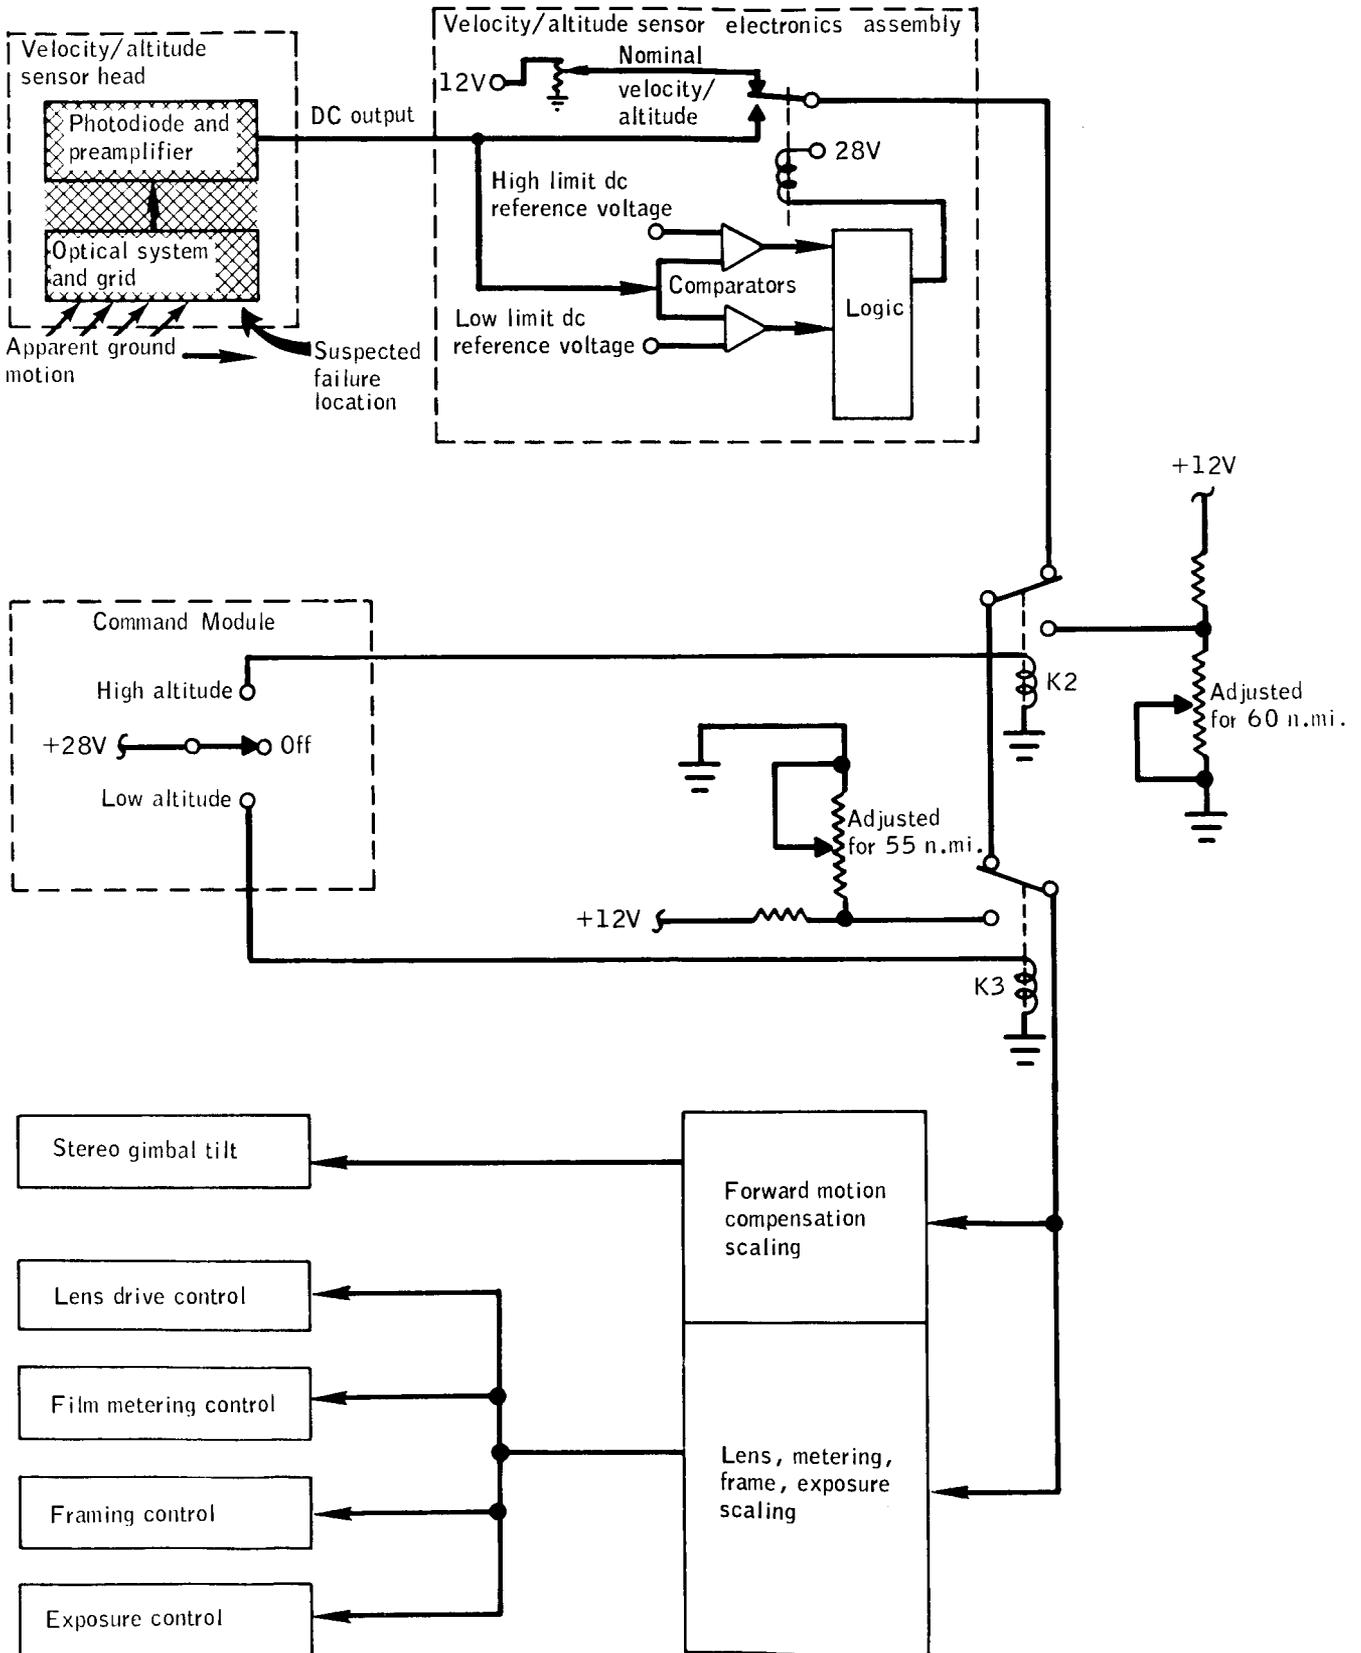
Figure 6-1.- Velocity/altitude output circuitry.

Telemetry data from the second panoramic camera pass on revolution 13 indicated that the velocity/altitude sensor output was erratic. The velocity/altitude sensor measured the rate of travel of the spacecraft relative to the lunar surface. The output signal from the sensor (fig. 6-1) controls the cycling rate of the camera and the forward motion compensation, as well as the exposure since the width of the exposure slit is dependent upon the scanning rate of the lens. The sensor operates in the range from 45 to 80 miles altitude. An override switch in the spacecraft provides the capability for locking out the sensor and substituting pre-set voltages which correspond to rates for the 55- and 60-mile altitudes.

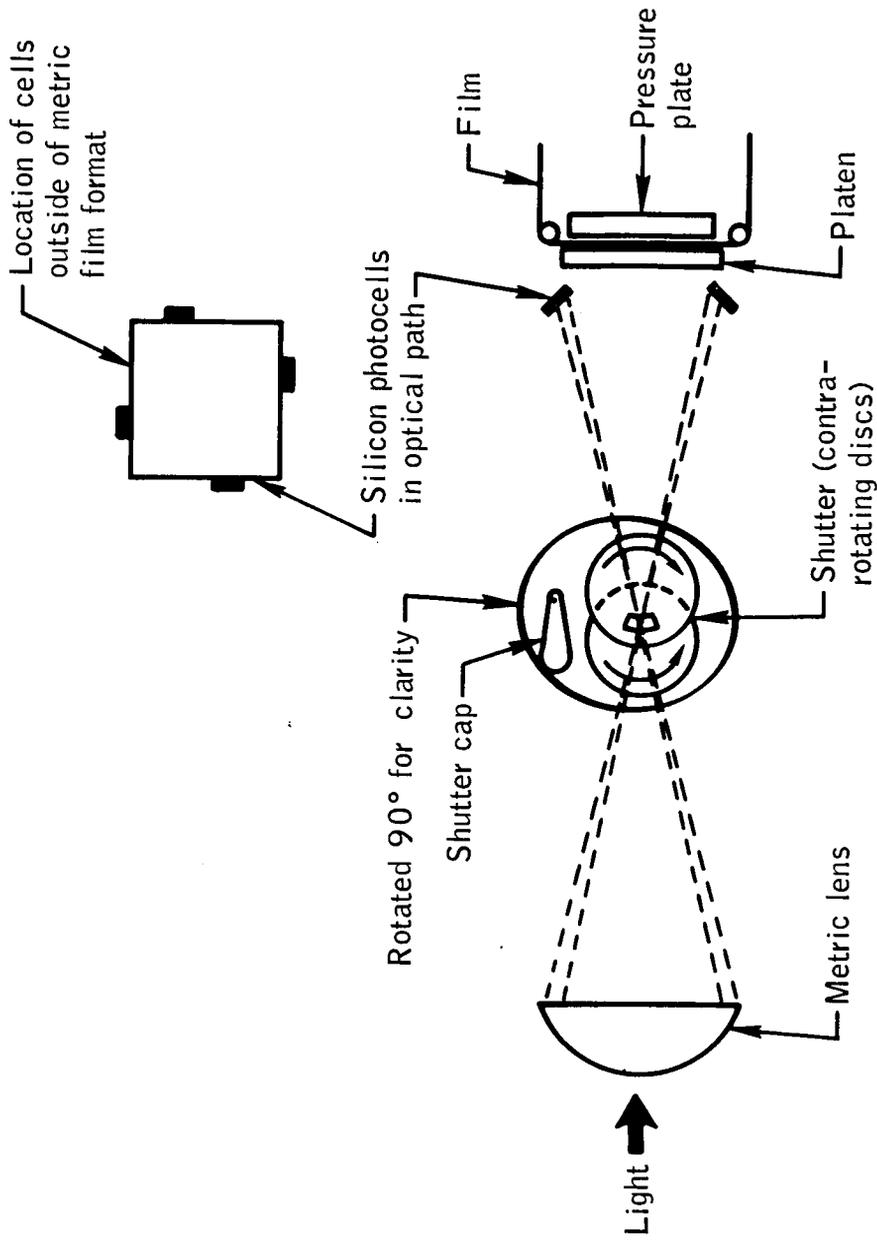
Figure 6-3.- Light energy path to photocells.

The pulse is generated by a light sensor and associated amplifier and a one-shot multivibrator (fig. 6-2). The light sensor consists of four photo diodes, with one near each edge of the 4-1/2 by 4-1/2 inch picture format (fig. 6-3). All four diodes are connected in series.

During Apollo 15 and 16, this pulse was absent only at the very low light levels, thereby indicating that the Apollo 17 discrepancy may have been due to a threshold shift in the light sensor circuitry. A 50-foot strip of metric photography from revolution 62 was processed in order to establish whether this was the case or some other problem was actually reducing the light being transmitted to the film.

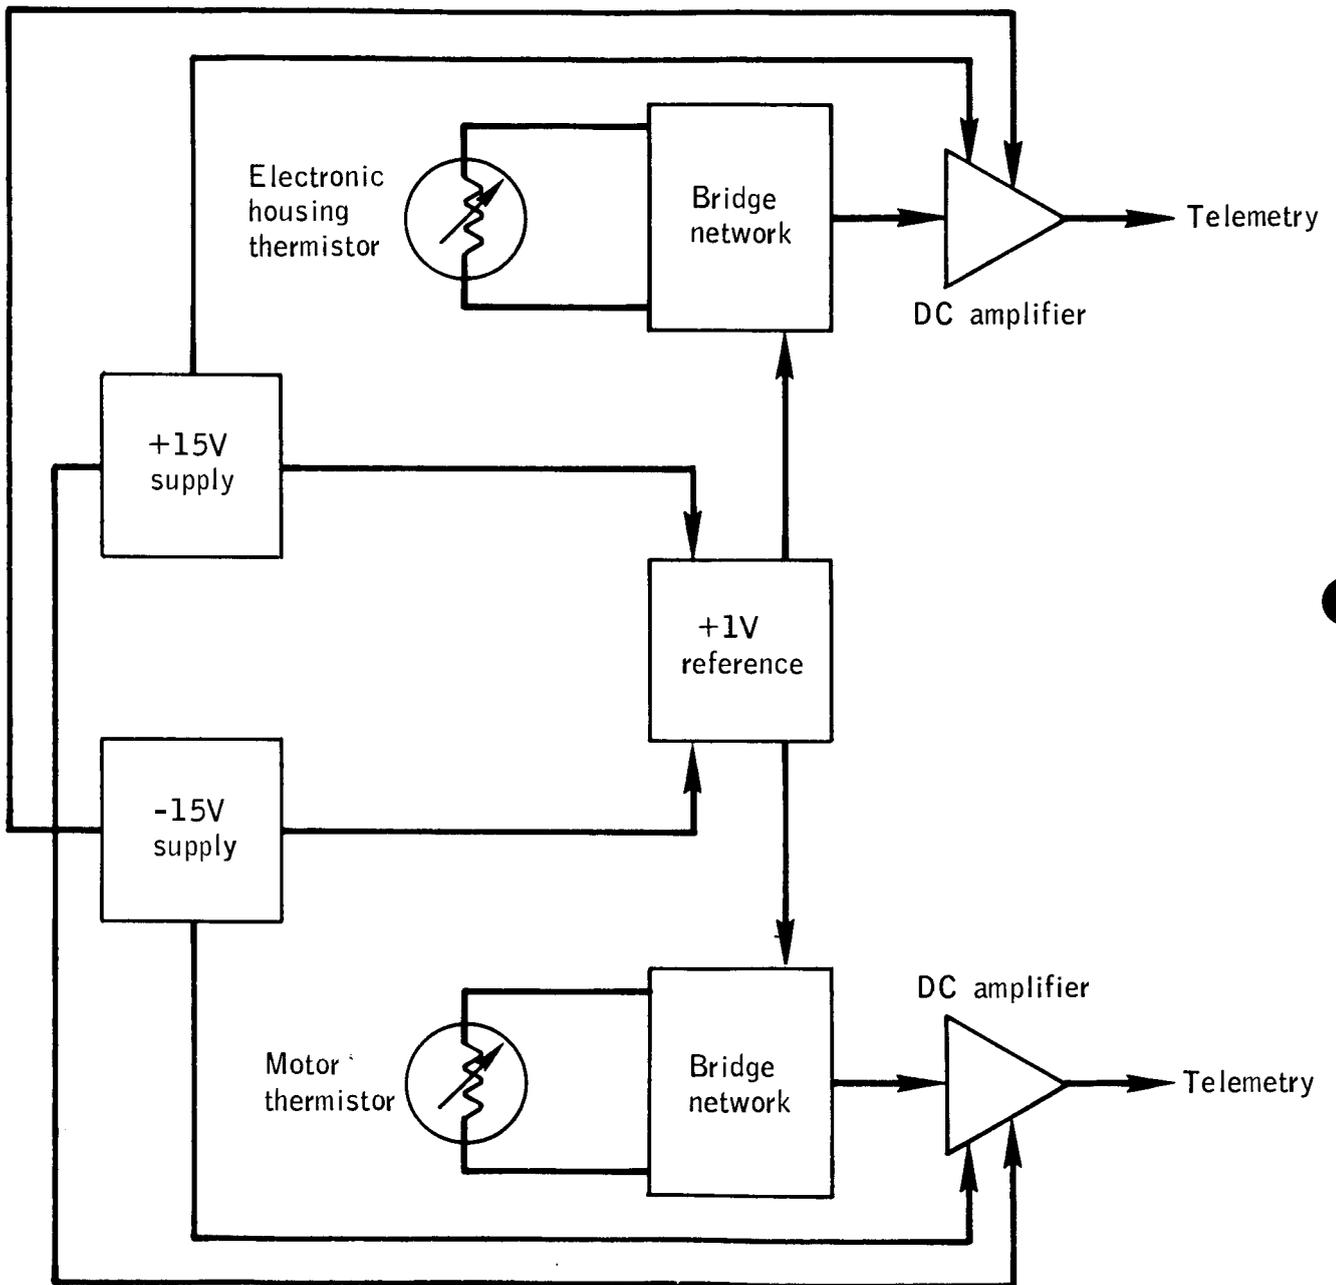
Figure 6-5.- Block diagram of ultraviolet spectrometer temperature sensing circuits.

A block diagram of the temperature sensing circuits is shown in figure 6-5. Each thermistor temperature sensor is connected to its own bridge network which in turn drives a d-c operational amplifier whose 0- to 5-volt output is then telemetered. Both temperature circuits are identical and independent except that: (1) they share common returns, (2) they share common ± 15 volt power supplies, and (3) each bridge network is biased with a common plus 1-volt precision stable reference. The plus 1-volt reference is derived via a temperature-stabilized zener diode and an inverting d-c amplifier powered from the minus 15-volt supply.
